DEPARTMENT OF TRANSPORTATION

Quality Assurance and Source Inspection

Contract #: 04-0120F4Cty: SF/ALA Rte: 80 PM: 13.2/13.9File #: 1.28**WELDING INSPECTION REPORT****Resident Engineer:**Pursell, Gary**Address:** 333 Burma Road**City:** Oakland, CA 94607**Report No:** WIR-013435**Date Inspected:** 23-Apr-2010**Project Name:** SAS Superstructure**OSM Arrival Time:** 1100**Prime Contractor:** American Bridge/Fluor Enterprises, a JV**OSM Departure Time:** 1930**Contractor:** American Bridge/Fluor Enterprises, a JV**Location:** Job Site**CWI Name:** See Below**CWI Present:** Yes No**Inspected CWI report:** Yes No N/A**Rod Oven in Use:** Yes No N/A**Electrode to specification:** Yes No N/A**Weld Procedures Followed:** Yes No N/A**Qualified Welders:** Yes No N/A**Verified Joint Fit-up:** Yes No N/A**Approved Drawings:** Yes No N/A**Approved WPS:** Yes No N/A**Delayed / Cancelled:** Yes No N/A**Bridge No:** 34-0006**Component:** Orthotropic Box Girders**Summary of Items Observed:**

WELDING INSPECTION REPORT

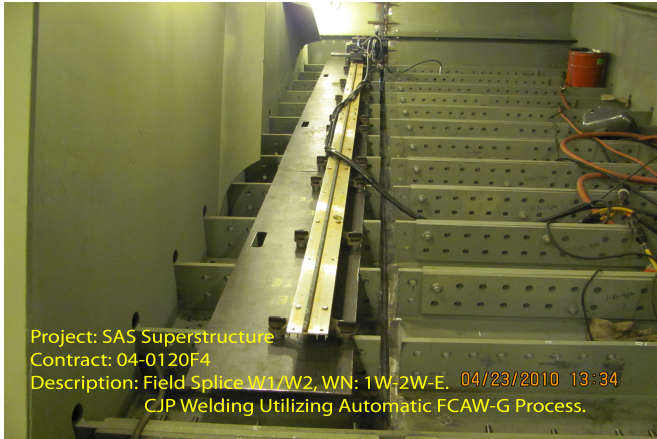
A) Field Splice W1/W2

The QAI observed the automatic Flux Cored Arc Welding (FCAW-G) welding during the Complete Joint Penetration (CJP) groove welding of the side plate field splice performed by Songtao Huang ID-3794. The single-v-groove joint appeared to comply with the AWS joint designation identified as B-U2a-GF. The welder, Mr. Huang, utilized the FCAW-G welding process as per the WPS ABF-WPS-D15-3042A-4 Rev. 0 which was also used as a reference by the Quality Control (QC) inspector Tom Pasqualone to monitor and verify the welding parameters and the surface temperatures during the welding operation. The Direct Current Electrode Positive welding parameters were verified and noted by the QC inspector and were noted as follows: 257 amps, 23.4 volts and a travel speed measured at 255 mm/minute. The minimum preheat temperature of 60 degrees Celsius and the maximum interpass temperature of 230 degrees Celsius were maintained.

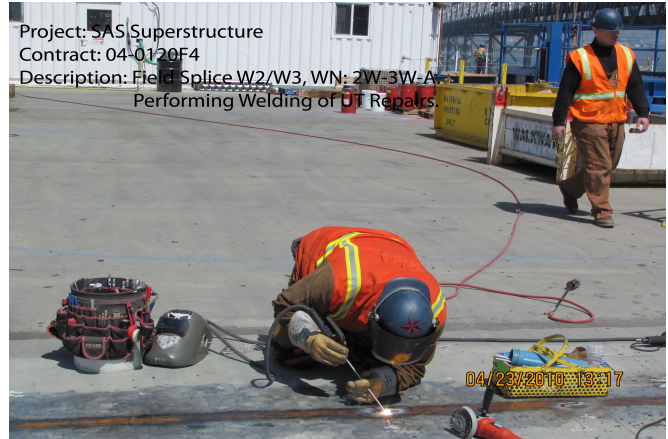
B) Field Splice W2/W3

The QAI observed the continued Ultrasonic Testing (UT) of the deck plate field splice identified as WN:

2W-3W-A. The testing was performed by the QC technician Steve McConnell utilizing a Krautkramer USM 35X. Mr. McConnell also utilized the UT Procedure identified as SE-UT-D1.5-CT-100 Rev.4 during the examination of the CJP. The QC technician performed the required longitudinal wave utilizing a 1" diameter transducer for base metal soundness and a .75 x .75 rectangular transducer to perform the shear wave testing during the testing for weld soundness. At the end of the shift there appears to be approximately a total of nine (9) rejectable discontinuities noted by the QC technician at this time.

Later in the shift, the QAI observed the excavation of two (2) unacceptable discontinuities discovered during the Ultrasonic Testing (UT) performed by the QC Technician, Steve McConnell. The excavations were performed by welding personnel Mitch Sittinger ID-0315 utilizing a high cycle grinder to remove the defects and at the conclusion of the grinding the surface appeared to be finished to a bright metal. The excavations were visually inspected and a Magnetic Particle Test (MPT) was performed and no rejectable indications were noted by the QC inspector. At this time, Mr. Sittinger commence the welding of the excavations utilizing the WPS identified as ABF-WPS-D15-1000-Repair Rev. 2. The QAI verified the DCEP welding parameters as 135 amps and the minimum preheat 60 degrees Celsius and the maximum interpass temperature of 230 degrees Celsius. The linear dimensions utilized the Y coordinates which were measured from the counterweight end of the Orthotropic Box Girder (OBG) and were noted as Y=25830mm and Y=26600mm. Later in the shift the QAI observed, at random intervals, the QC inspector monitoring and verifying the welding parameters. The repairs were completed during the scheduled shift.
